BULLETIN T-64-41

SUBJECT: TRIUMPH TR-4 WINDOW
WINDER REGULATOR

DATE: DECEMBER 10, 1964

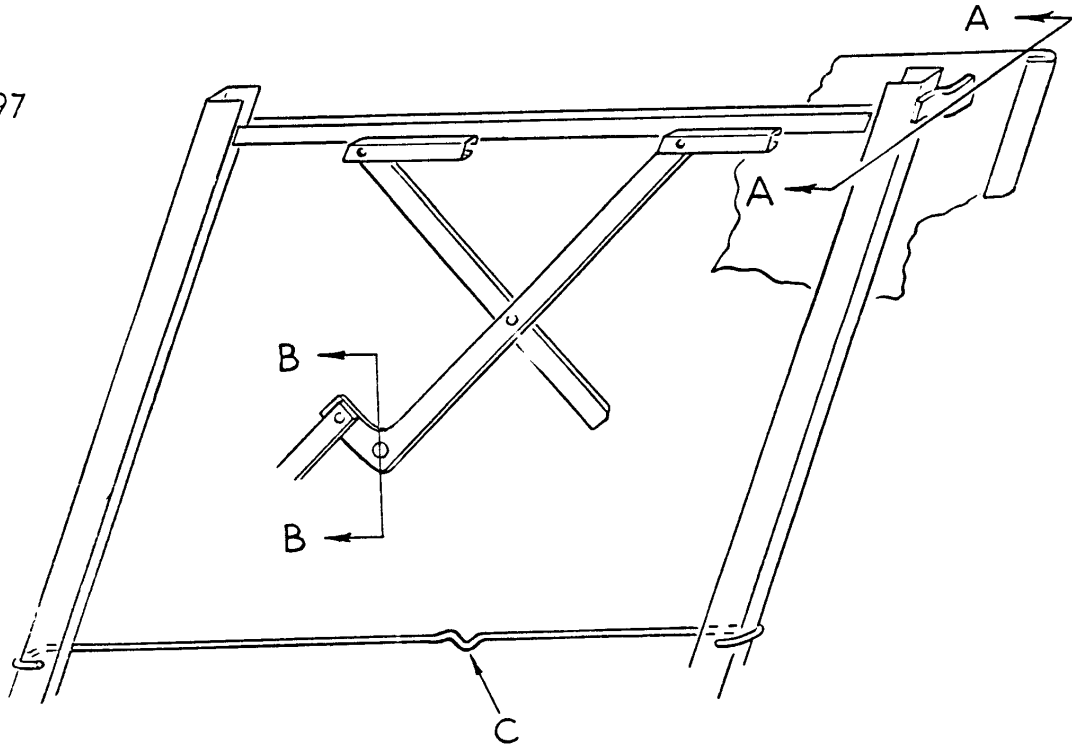
A-A

When reports of stiffness in the operation of the door glass are received, the following procedure should be adopted which will prevent straining and damage to the regulator. The same instructions should also be followed when renewing a regulator.

1. Remove trim panel.
2. Raise window and check the clearance of the glass fore and aft in the top of the rear channel. The recommended clearance is .030" which should be maintained for the whole length of the channel. Excess clearance will allow tilting and the jamming of the glass and insufficient clearance will produce stiff operation. Clearance can be obtained by the use of packing washers between the inner door panel and top channel bracket (see illustration A-A).
