Replacement Door Glass Part Number V038 TR-4/6

T-72 -C-2 August, 1972

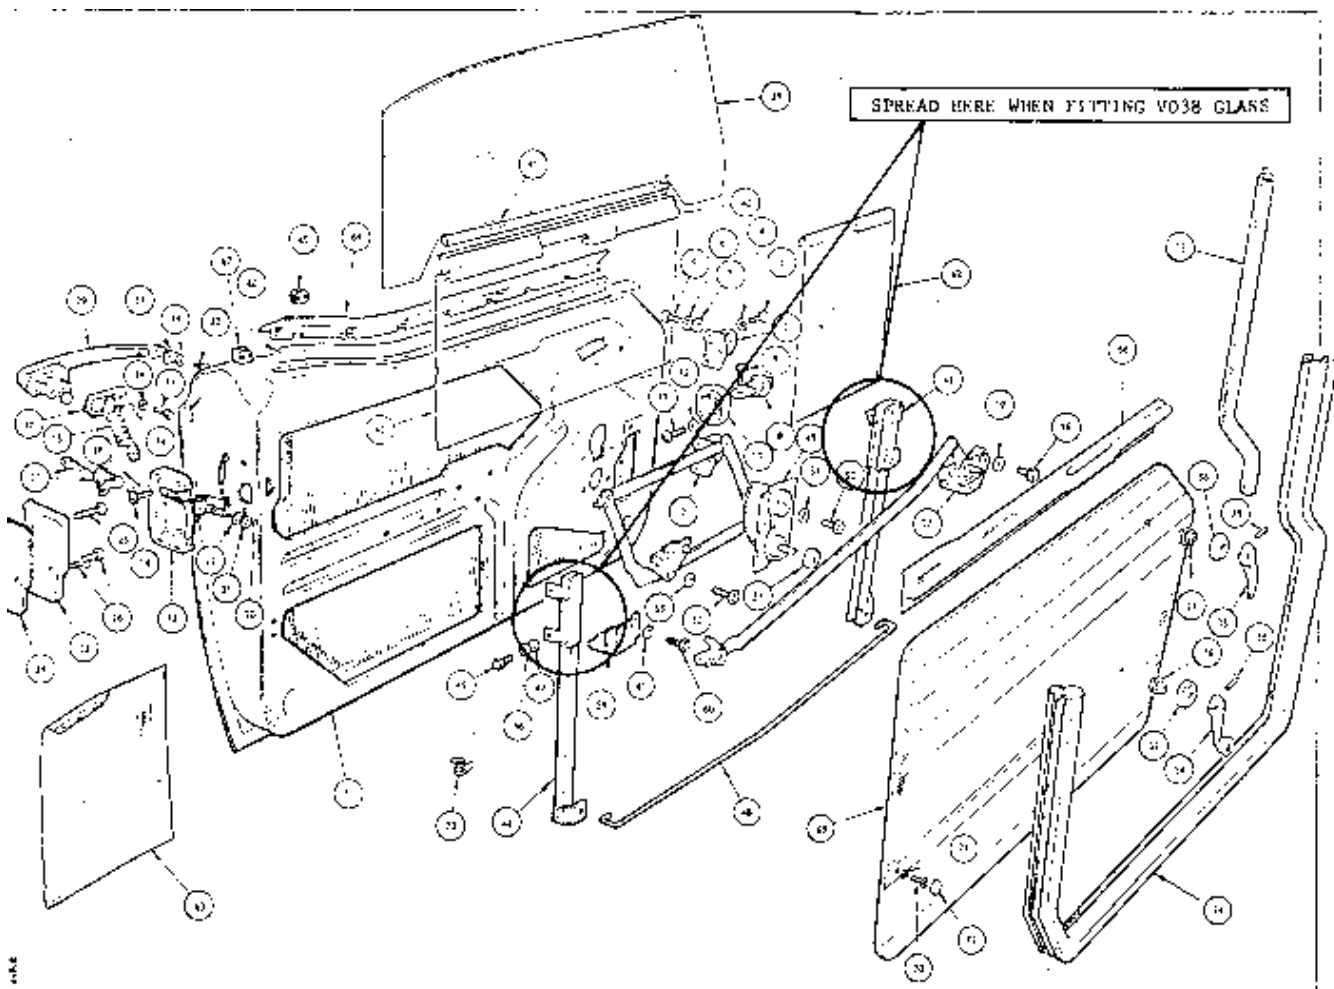
Difficulty has been experienced with the installation of the door glass, part number V038. The reason for this is that the original glass supplied with the vehicle is 0.190" thick, whereas the replacement glass (part number V038) is 0.230" thick. The problem, however, can be overcome by simply spreading the nylon finger clamps on the upper portion of each window channel by inserting a suitable tool such as a screwdriver. It is not necessary to remove the channels from the door.
